Outlet Home Inspections

Property Address:

ABC St, Jersey City, NJ 07000

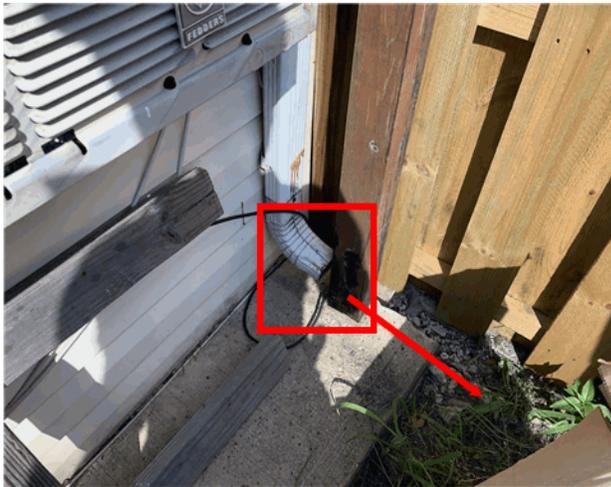
1) Grading Conditions R During the home inspection the downspouts were observed to dump water directly adjacent to the foundation walls. This promotes moisture build up on the foundation wall that can potentially penetrate the house. The downspouts should be extended 4-6 ft. out to dump water away from the foundation.

Downspout should be extended away from house.

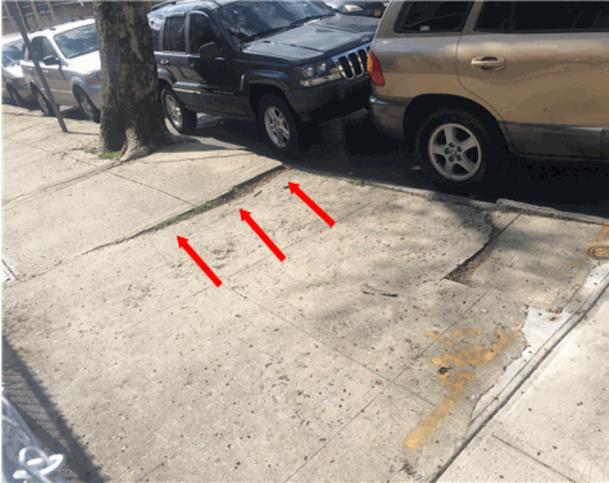
3) Sidewalk Conditions R The surface was raised or settled. This may cause tripping hazards. These should be repaired for safety. It is suggested that a "Licensed Masonry Contractor" be contacted for further evaluation and repair.

Raised sidewalk observed in front of house.

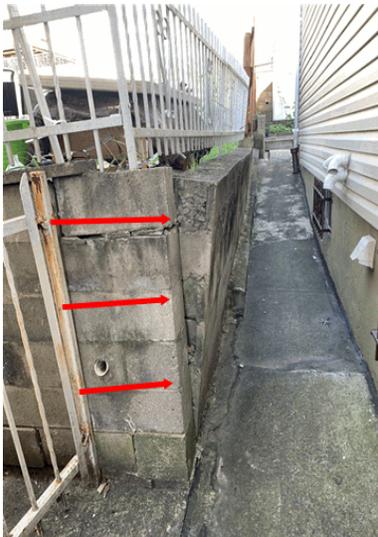
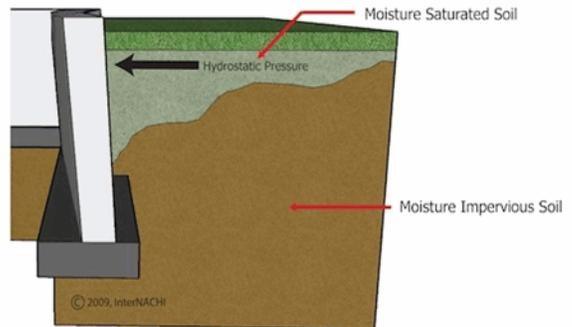
5) Retaining Wall Conditions R The retaining wall in the backyard was severely leaning/bowing out and cracks were observed. Repair is warranted in the near future. It is suggested that a "Licensed General Contractor" be contacted for further evaluation and repair.

Retaining wall extremely leaning/bowing out.

Figure demonstrating leaning of retaining wall.

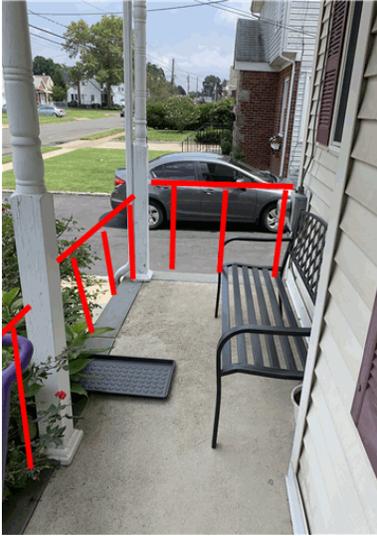
No guard or hand railings were present in the front porch. For increased safety, client should consider installation of a railing. Client should consult with a qualified contractor for information on current standards.

No guard rails present around the front porch.

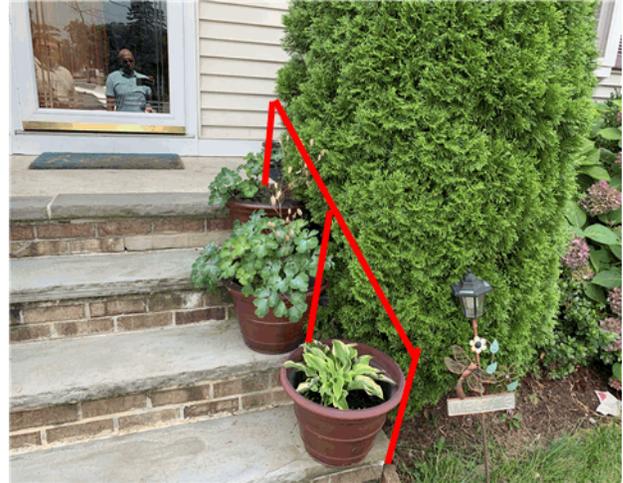
No handrails observed going up the front stairs.

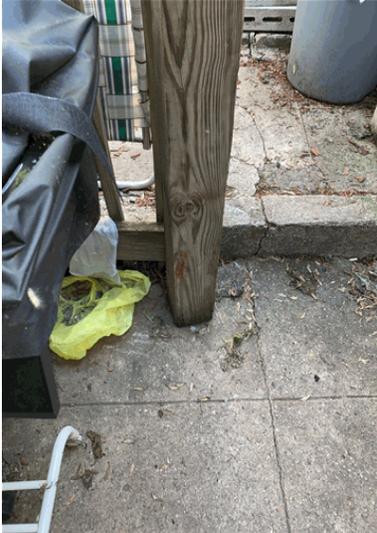
-One of the wood posts for the wood deck was observed to be physically twisting. The posts is not anchored down and Home Inspector suspects that there is no footing beneath the footing.

Wood support post observed to be twisting and Home Inspector suspects no footing installed.

It is suggested that a "Licensed General Contractor" be contacted for further evaluation and repair.

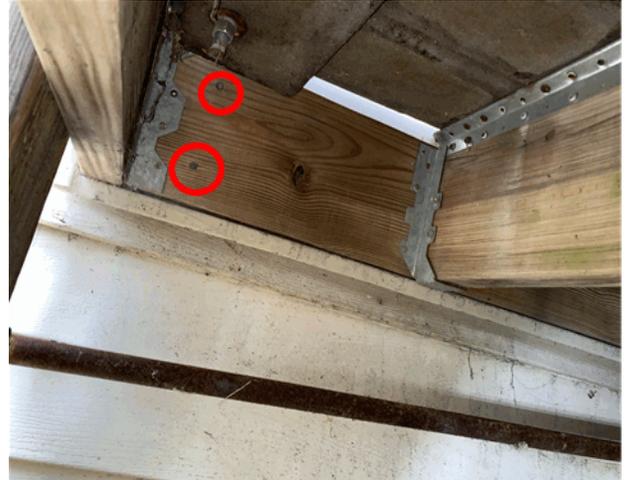
Nails instead of anchor bolts used to fasten ledger board.

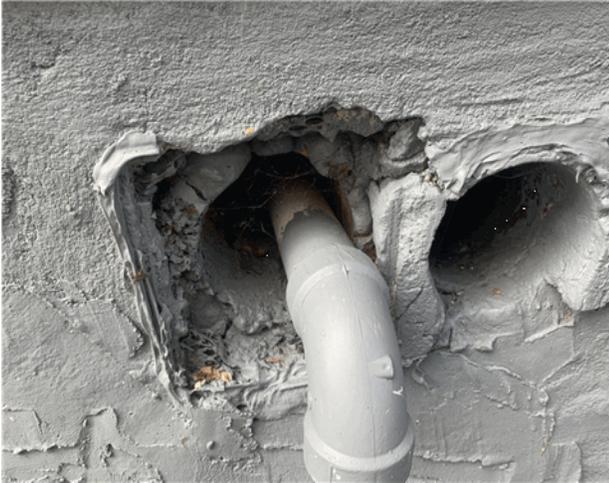
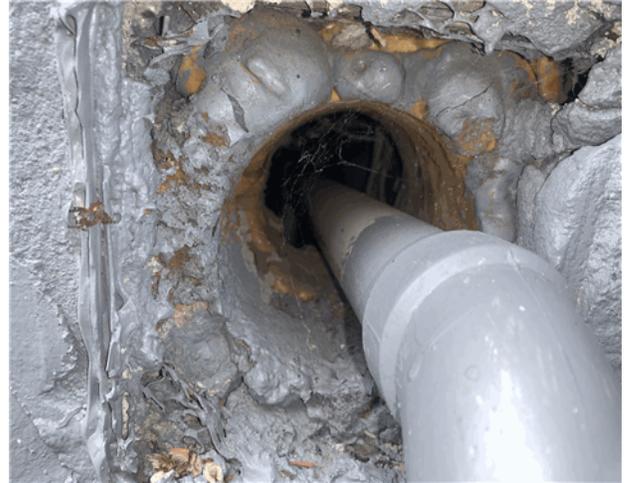
R The exterior foundation wall was observed to have penetrations entering the basement space. This can potentially allow moisture and pests to enter the basement space. It is suggested that a "Licensed General Contractor" be contacted for further evaluation and repair.

Penetrations should be sealed entering the basement space.

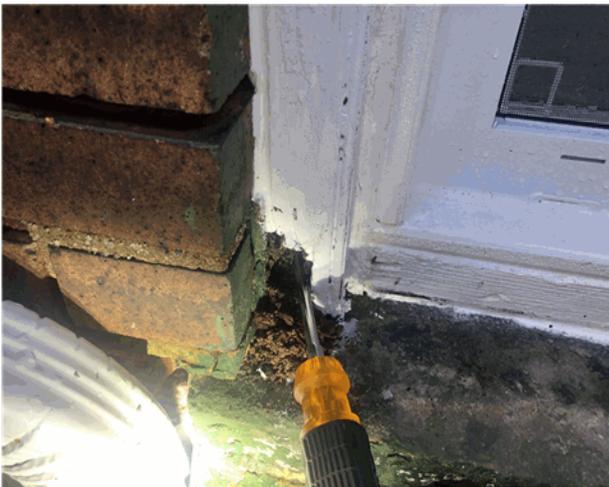
Exterior frame weathering and some deterioration (wood rot) was observed. Recommend repairs / maintenance as needed. Water penetration may have occurred. It is suggested that a "Licensed General Contractor" be contacted for further evaluation and repair.

Deterioration observed to exterior window.

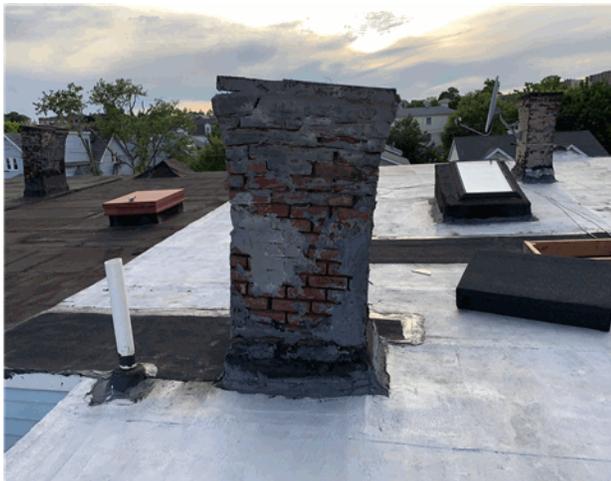
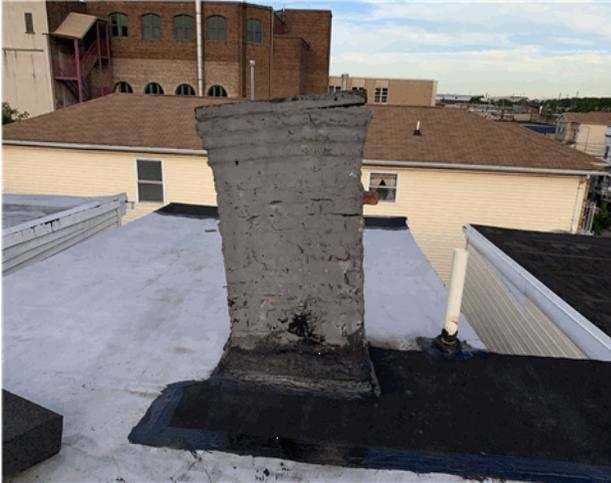
-The entire chimney was observed to be covered with tar. This is usually to patch up cracks and/or mortar deterioration to minimize leaks. However, the tar will dry and crack overtime with weather conditions. The chimney should be rebuilt in the near future.

-The chimney was observed to be physically leaning during the inspection. Additionally it was observed to be deteriorating.

Chimney deteriorating, leaning, and wrapped in tar.

It is suggested that a "Licensed Masonry Contractor" be contacted for further evaluation and repair.

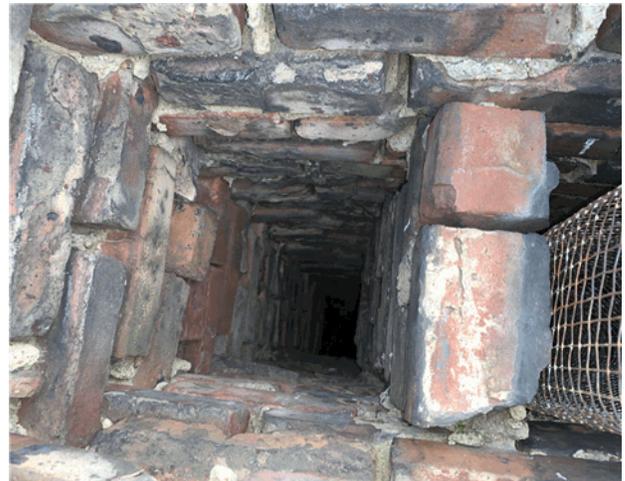
Chimney observed to be unlined.

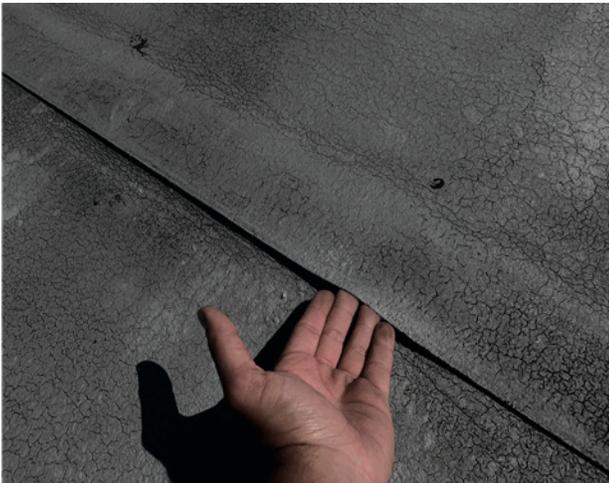
R The flat or low-sloped roof covering material showed signs of blistering and "alligator skin". Additionally the Home Inspector was able to pull up the roof layers at the seams. Maintenance and / or repair is recommended to the flat or low sloped roof. This usually consists of covering all exposed areas with additional flashing material, repairing or sealing any seams, any cracks in the flashing, or any cracks in the roofing material. Given this condition, it is possible that the roof has leaked at one time. Recommend further evaluation by a qualified roofing contractor.

The Home Inspector was able to pull back at seams.

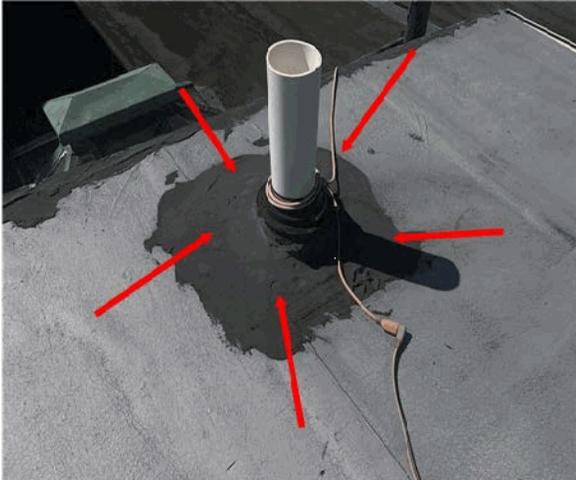
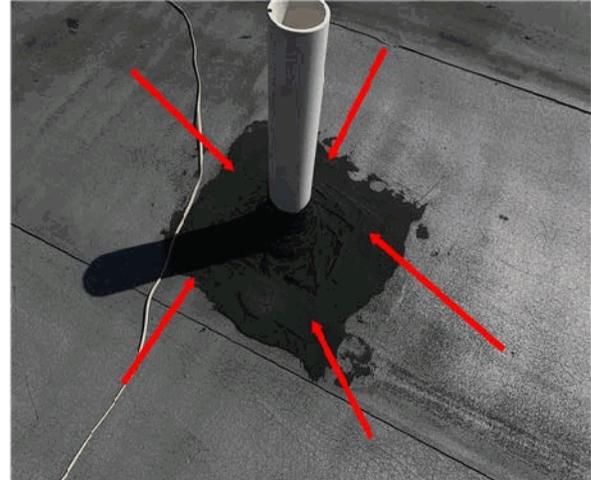
R The flashing had evidence of tar patching and repair observed around the plumbing stacks, seams, sidewalls, etc. Given this condition, it is likely that the roof has leaked at one time. Over time the tar will dry out and crack, letting water through again.

Tar patching observed around flashing for plumbing stacks.

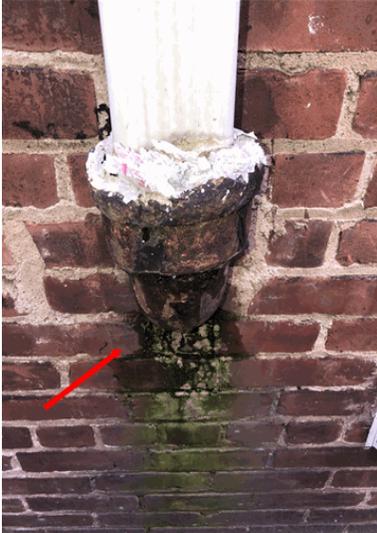
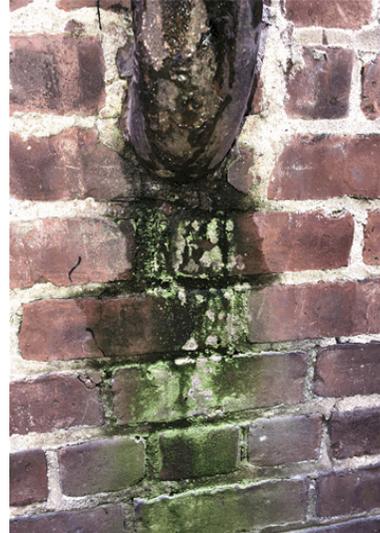
-Cast iron sub-surface drains were observed. Cast iron piping was commonly used in older homes, cast iron is designed to last 60 – 75 years. Cast iron tends to rust/deteriorate overtime. Directly below where the drains enter the house moisture stains were observed. These drains were not tested as a part of this inspection. Condition of underground pipes or location of their termination points (if any) is not determined as part of this inspection.

Moisture stains observed below cast-iron sub-surface drains.

It is suggested that a "Licensed General Contractor" be contacted for further evaluation and repair.

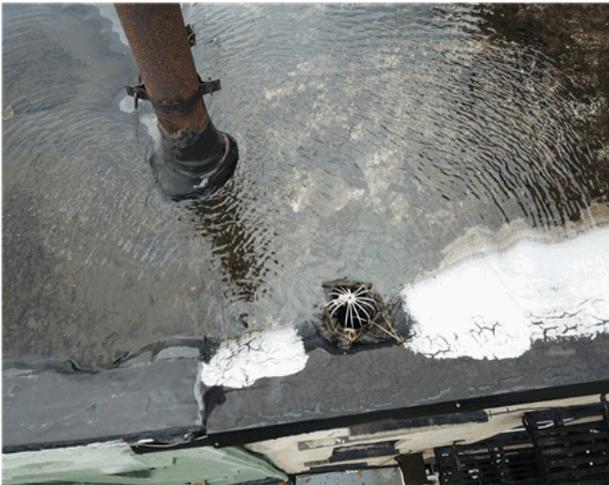
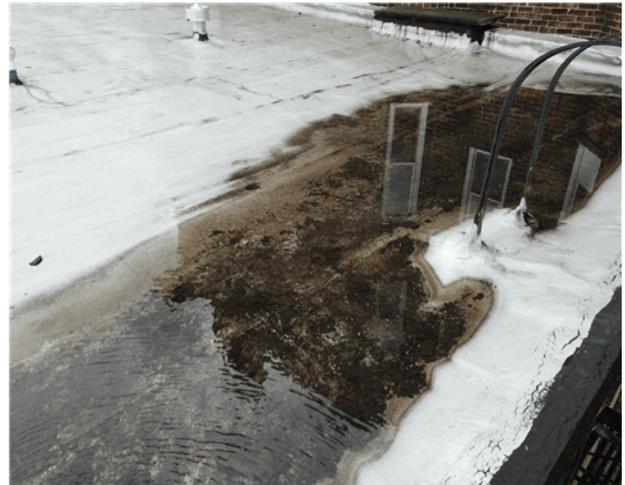
-Water was observed to be puddling in the back of the house. This could be due to a combination of lack of sloping and/or due to downspout being clogged. It is suggested that a "Licensed General Contractor" be contacted for further evaluation and repair.

Water was observed to be puddling in the back of the house.

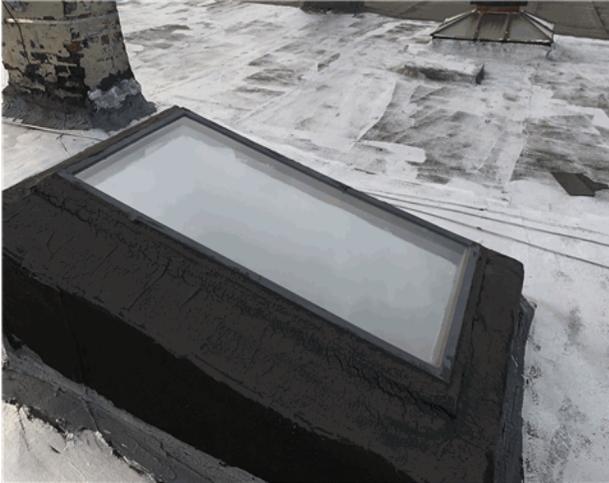
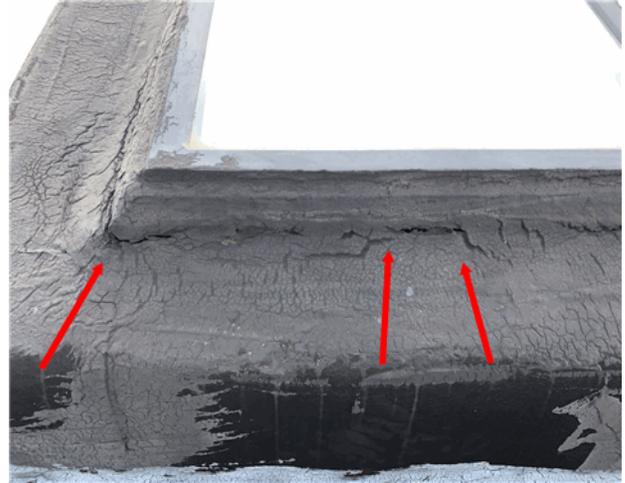
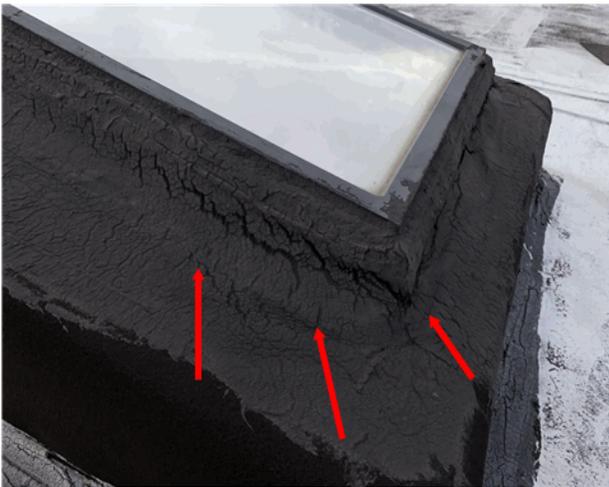
The flashing had evidence of tar patching and repair observed around the skylight. Given this condition, it is likely that the roof has leaked at one time. Over time the tar will dry out and crack from UV exposure, letting water through again. The tar was observed to be cracking in some areas.

Some cracks were observed in the tar around the skylight. Please note all skylights require periodic maintenance as they all historically leak overtime, specifically skylights on flat roof applications.

Zoomed out picture of skylight wrapped in tar.

Tar cracking in many areas. These are areas where moisture can penetrate.

Tar observed to be drying up and cracking.

It is suggested that a "Licensed General Contractor" be contacted for further evaluation and repair.

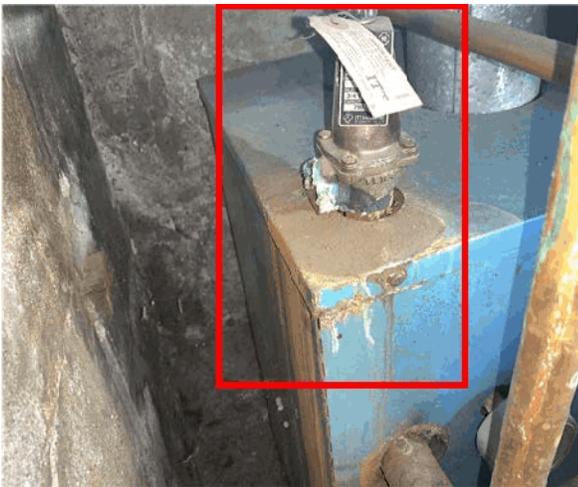
R TPR (temperature pressure relief) valve overflow pipes were missing on all three boilers at the time of the inspection. Additionally some signs of rust was observed on one of the boilers. Suggest installation of pipe for increased safety.

TPR pipe missing on boiler.

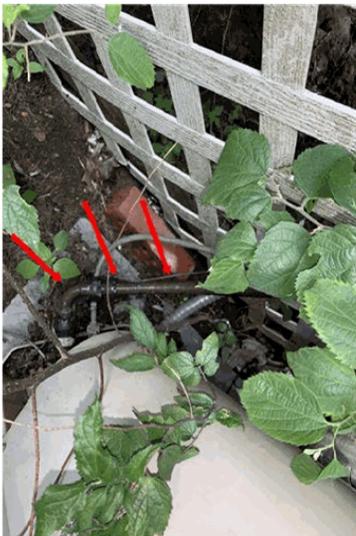
25) AC Unit Conditions R The following observations were made at the time of the inspection:
 -The insulation on the refrigerant lines was missing or deteriorated. Recommend installing this rather inexpensive pipe insulation to improve efficiency. Pipe insulation is available at most hardware

Line insulation missing on AC unit.

It is suggested that a "Licensed HVAC Contractor" be contacted for further evaluation and repair.

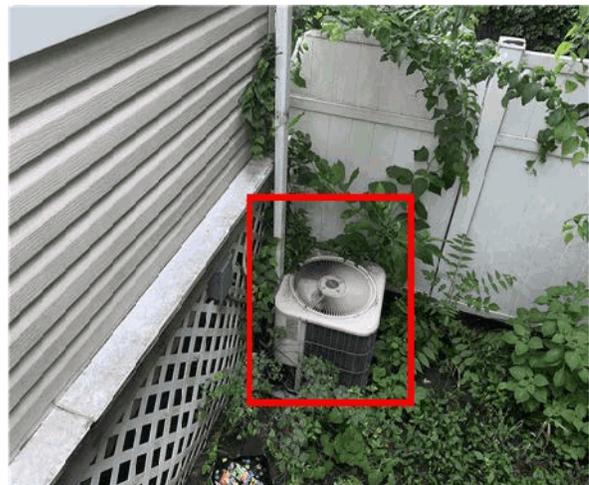
Vegetation observed wrapped around AC unit.

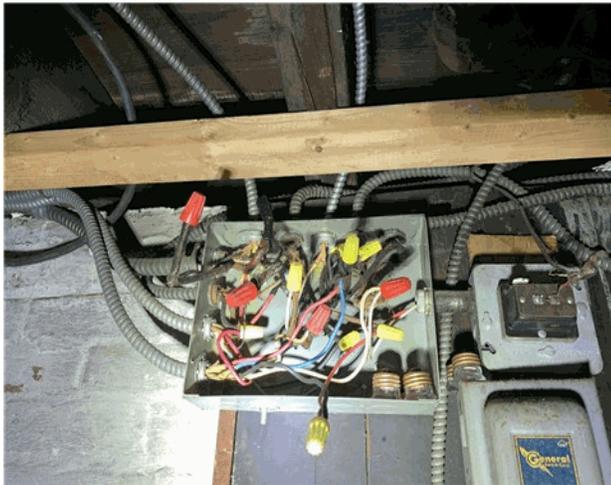
Some cloth covered wiring observed throughout the basement boxes/panels.

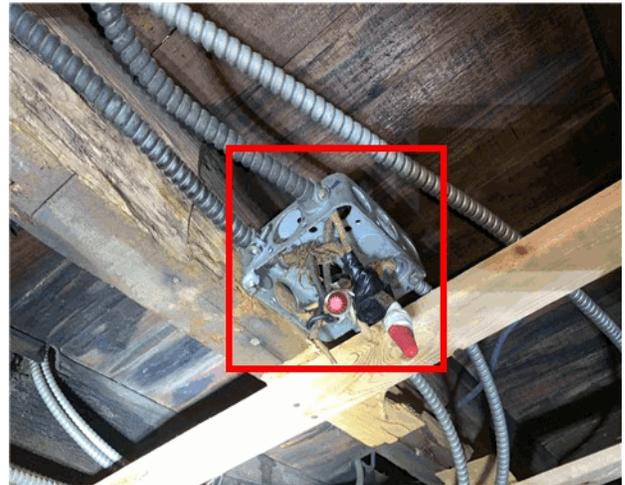
Missing junction box cover observed with exposed cloth wiring.

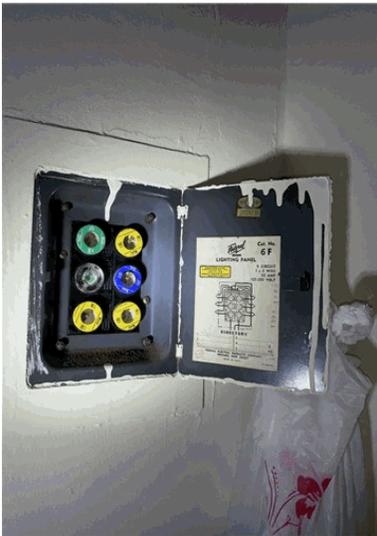
-Fuses were present. The inspector was unable to determine the fuse amperage rating without removing main fuses. Pulling of fuses or disruption of power is outside the scope of this inspection. Fuses are no longer used in today's construction. The possibility exists where fuse sizes can be easily changed causing a potential hazard. Whenever fuses are present, client should consult a licensed electrician to confirm correct fuse sizes. Client should consider upgrading panel to conform to today's safety standards.

Federal Pacific fuse panel observed in 2nd floor hallway.

It is suggested that a "Licensed Electrical Contractor" be contacted for further evaluation and repair.

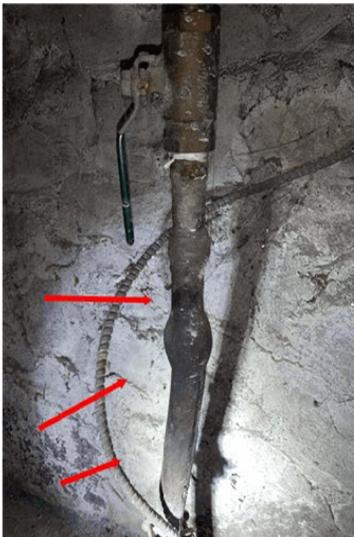
R Lead pipe was observed in the main water line entering the house prior to the water meter (refer to attached picture). Lead pipe was identified based on three telltale signs including flexibility of pipe, gooseneck, and nickel/silver look of exterior of pipe. Replacement of a lead service line may be the responsibility of both the utility and homeowner. Homeowner should contact their water system to learn about how to remove the lead service line. Evaluation of Lead Paint or Lead Plumbing Piping is outside the scope of the inspection (refer to pre-inspection agreement).

Lead water main lead-in observed.

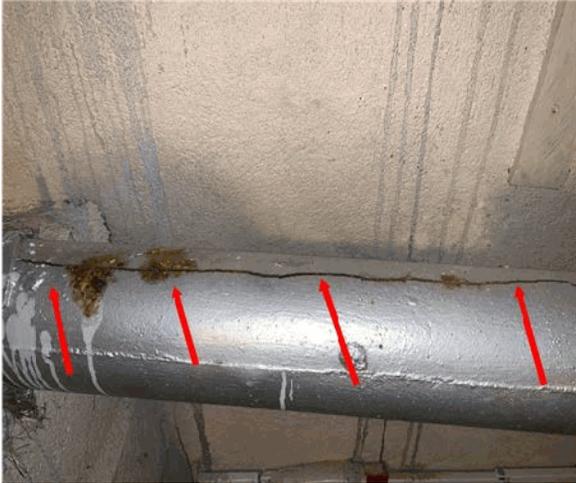
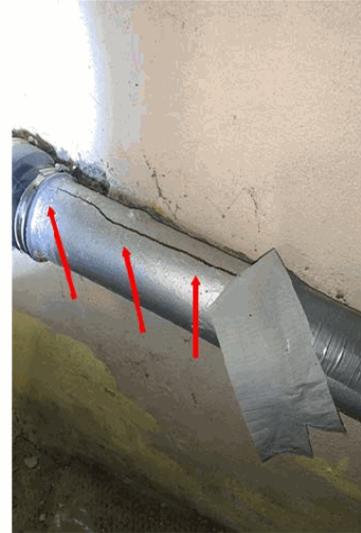
R The waste lines had signs of corrosion (although painted silver) and was cracked through the center. The drain lines appear to have reached the end of their useful life span. Recommend further evaluation by a

Cast iron piping was commonly used in older homes, cast iron is designed to last 50 -60 years. Cast iron tends to rust/deteriorate overtime. Some areas of piping may be approaching the end of their useful life. Client should consult a licensed plumber for further information.

Cast iron pipe was observed to be cracked dead in center.

Cast iron pipe was observed to be cracked dead in center and covered by duct tape.

licensed plumber.

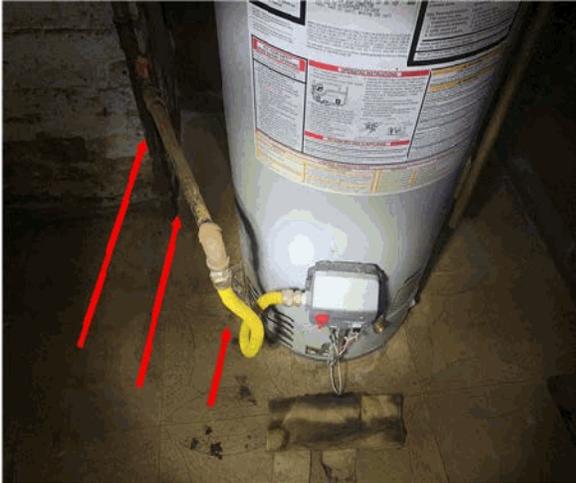
R Improper plumbing and a sediment trap (drip leg) was observed to be missing/improperly installed on the water heater. Sediment traps are designed to catch sediment, in natural gas, before it enters into the water heater. It is suggested that a "Licensed Plumbing Contractor" be contacted for further evaluation and repair.

Improper plumbing and missing sediment trap on gas line leading to the water heater.

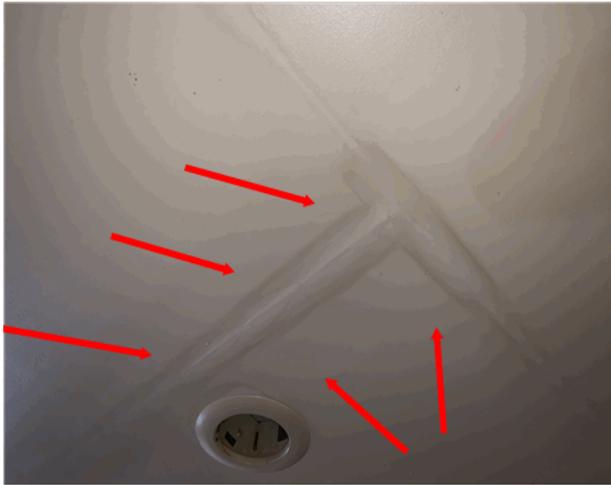
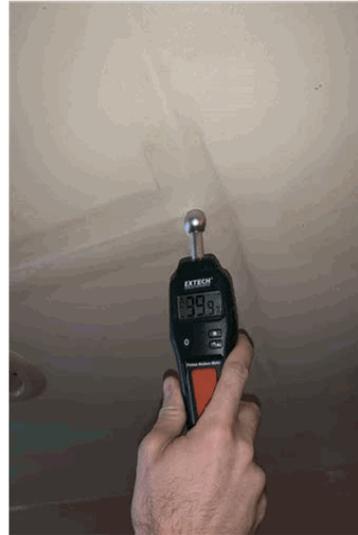
Moisture stains were observed in the ceiling in the top floor. When checked with a moisture meter the area indicated a wet / active leak condition. Recommend further evaluation and repair as needed by a qualified / licensed contractor. Please refer to limitations of inspection regarding mold / moisture related conditions.

Moisture stains observed in ceiling in top floor.

Active moisture detected when tested with moisture meter.

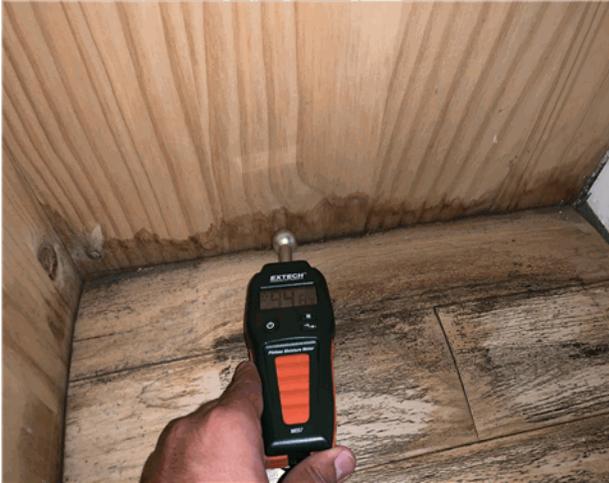
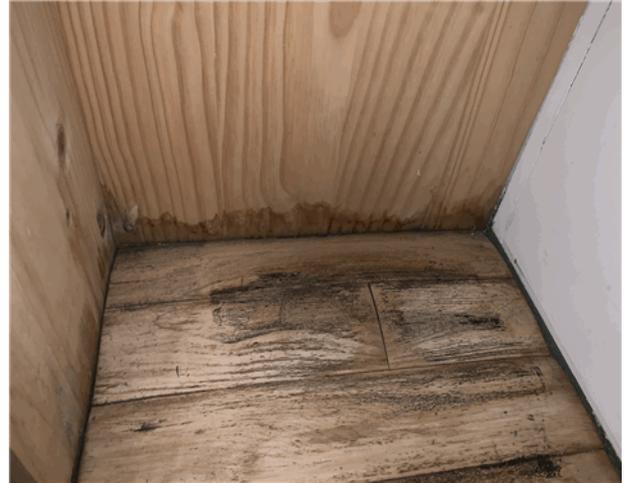
Moisture related damage was observed in the master bedroom closet. When tested with moisture meter an active reading was detected. Hidden evidence may exist in areas not readily visible or accessible. Recommend repair. Please refer to limitations of inspection regarding mold / moisture related conditions. It is suggested that a "Licensed General Contractor" be contacted for further evaluation and repair.

Active moisture detected in master closet walls/floors.

Moisture damage observed in master closet walls/floors.

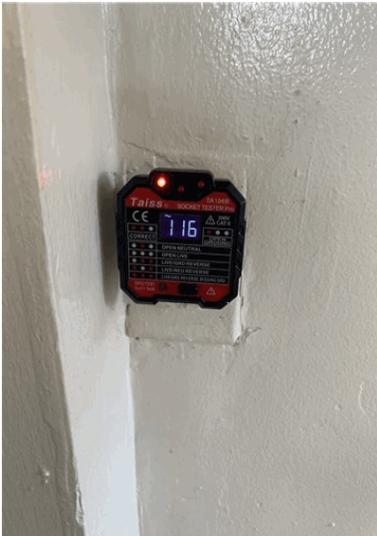
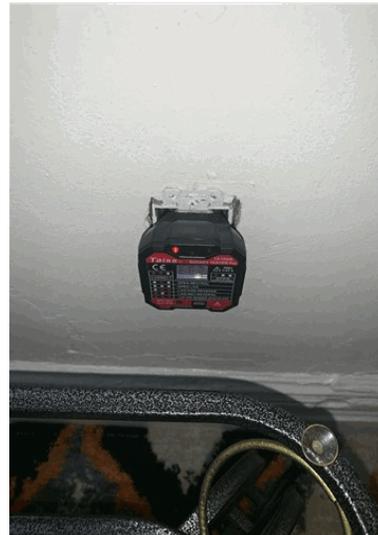
-Three pronged outlets did not test for proper ground in some of the bedrooms. Recommend further evaluation and repairs by a licensed electrician prior to close.

Three prong outlet did not test for grounding in back bedroom.

Three prong outlet did not test for grounding in living room.

It is suggested that a "Licensed Electrical Contractor" be contacted for further evaluation and repair.

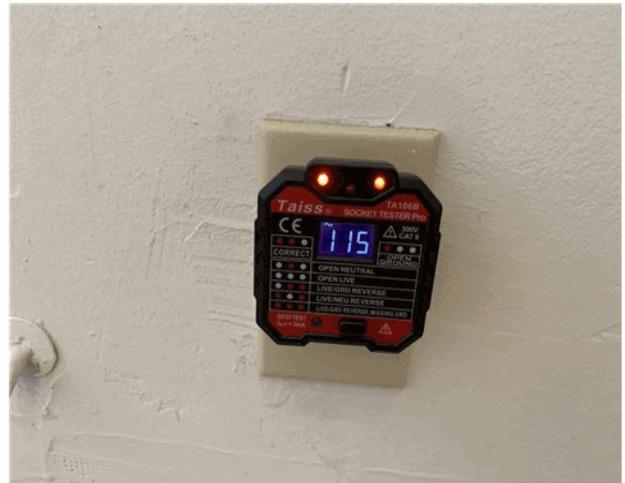
-Reverse polarity was noted at outlet located in back bedroom. Reverse polarity, (hot and ground / neutral reversed) are usually corrected by minor wiring adjustments at the specified item. However, when a number of these conditions are observed, client should consult a licensed electrician.

Reverse polarity detected at outlet in back bedroom.

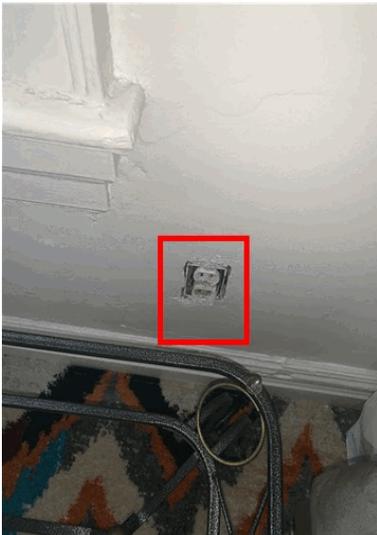
-Missing receptacle covers were observed in some of the rooms. Recommend covers be installed for safety.

Missing receptacle cover observed missing in living room.

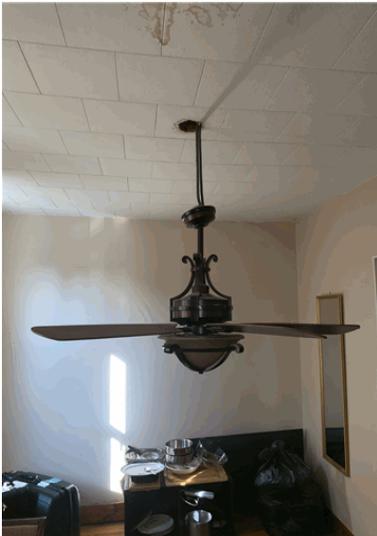
The ceiling fan in dining room completely came down. It appears it was not properly secured. This is a big safety concern and all other ceiling fans should be inspected to ensure they are safely and properly secured. Additionally the ceiling fan and lighting was not operational. Recommend further evaluation and repair as needed by a qualified / licensed contractor.

Ceiling fan in dining room came completely down.

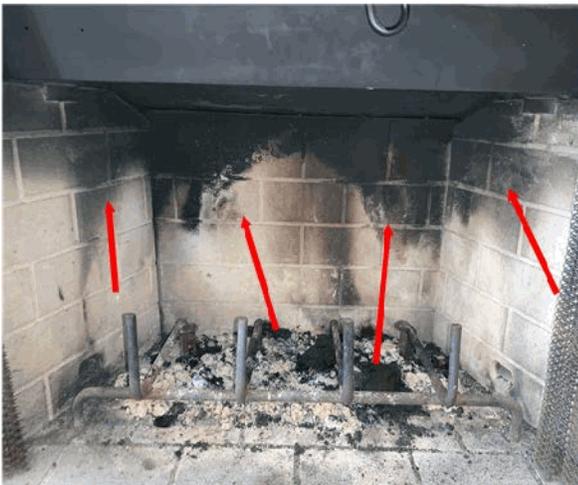
Recommend cleaning and further inspection of fireplace/chimney.

Recommend chimney fire block and flue cleaning by a chimney sweep specialist. Creosote can accumulate and become a fire hazard if the fireplace and flue are not cleaned regularly. It is suggested that a "Licensed Chimney Contractor" be contacted for further evaluation and repair.

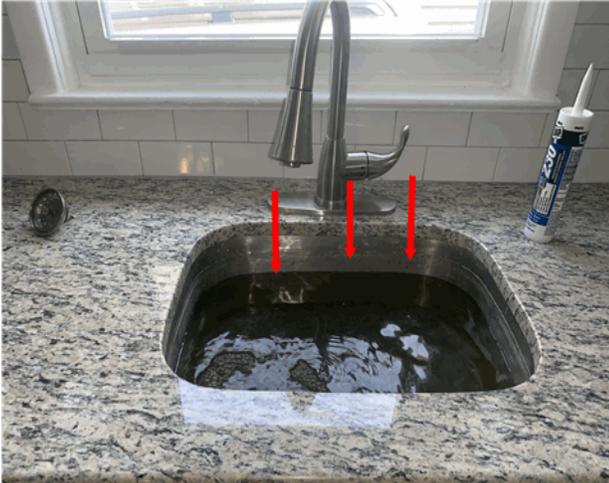
should have a smooth interior surface that allows the free flow of drain water and prevents waste buildup clogs. It is suggested that a "Licensed Plumbing Contractor" be contacted for further evaluation and repair.

The kitchen sink was observed to be clogged and not draining

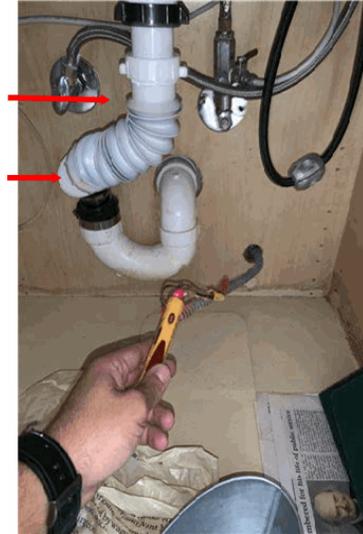
Loose and live electrical wire observed below kitchen sink with accordion piping on drain line.

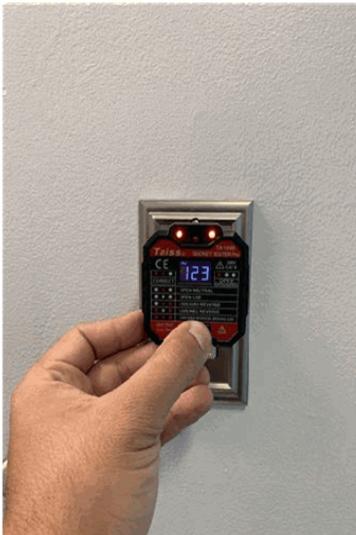
- 65) Electrical Conditions R The GFCI (ground fault circuit interrupter) receptacle did not respond to the inspectors (external) trip test device. Replacement and / or repair is needed. Recommend further evaluation and / or repair by a licensed electrician prior to close.

GFCI outlet did not trip in 1st floor.

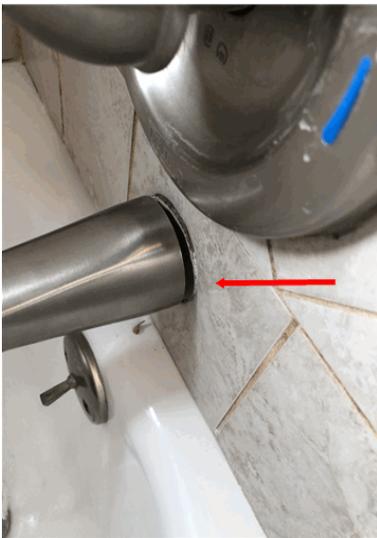
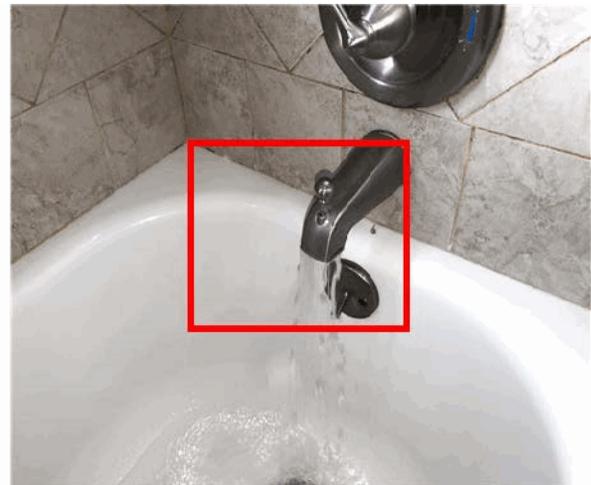
Diverter loose to the wall in bathtub in 2nd floor bathroom.

Diverter releasing water while showerhead was operating.

It is suggested that a "Licensed General Contractor" be contacted for further evaluation and repair.

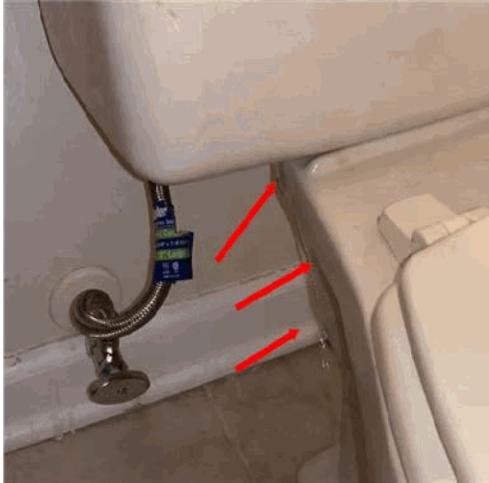
Toilet was leaking water from tank.

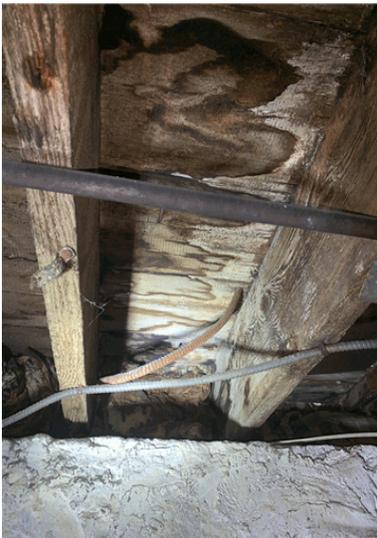
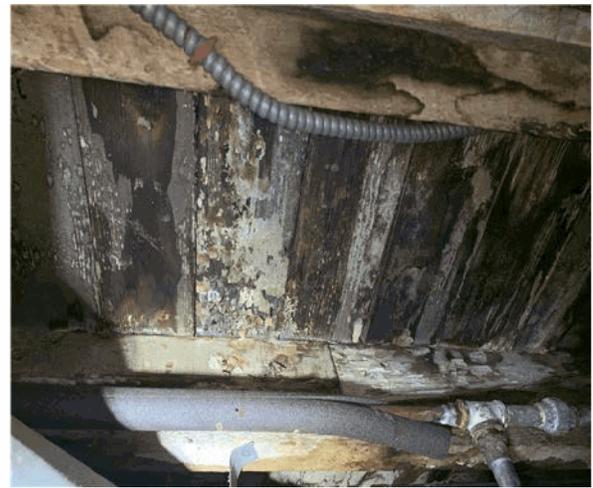
Moisture damage and microbial growth observed in exposed bsmt ceiling.

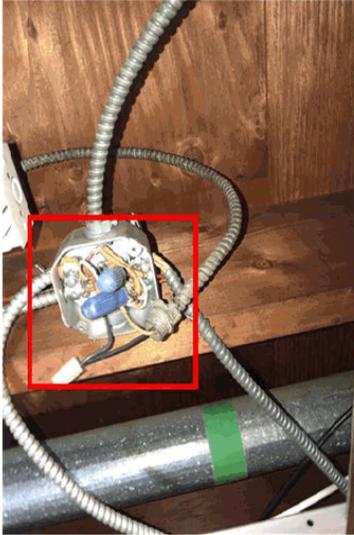
Junction box cover missing near dryer in ceiling.

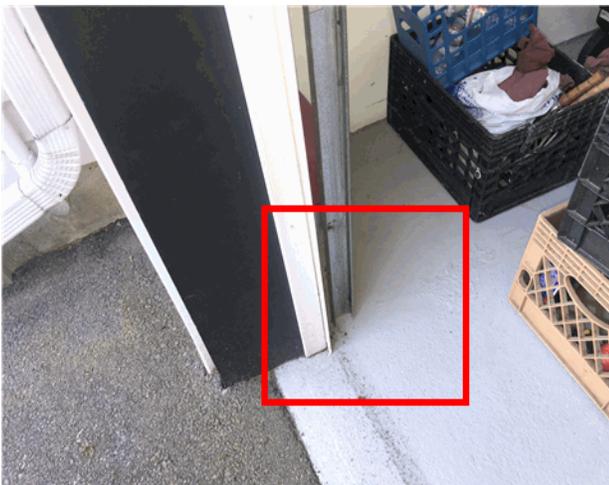
R The door opener safety reverse electric eye was missing; however there was an auto reverse feature for the vehicle door. Recommend installing a safety reverse eye within a few inches off the ground for additional safety.

Safety eye missing on both sides of garage door.

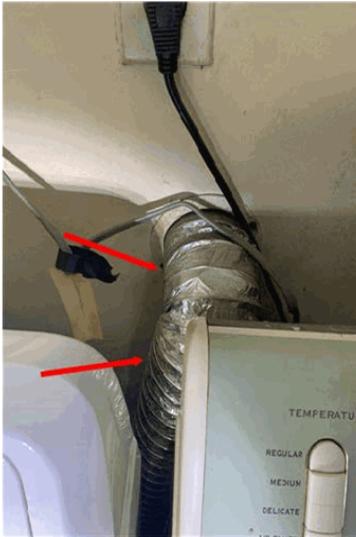
Foil duct observed for dryer.

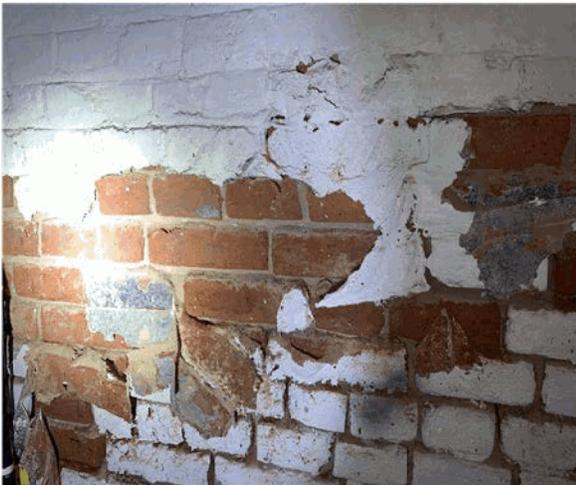
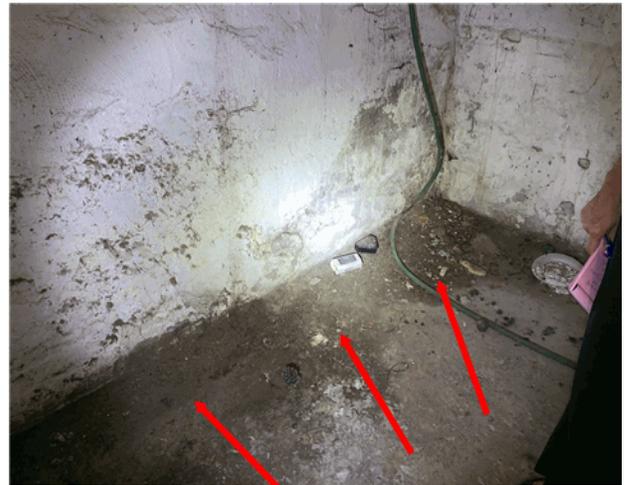
Evidence of previous water penetration was observed (stains, rust, watermarks) at the wall / floor area. Client should obtain disclosure / history information from the seller regarding any previous water penetration. Client should also consult a waterproofing contractor.

Interior paint observed to be flaking off in the basement.

Moisture stains observed in walls and ground. Appears to be seeping in.

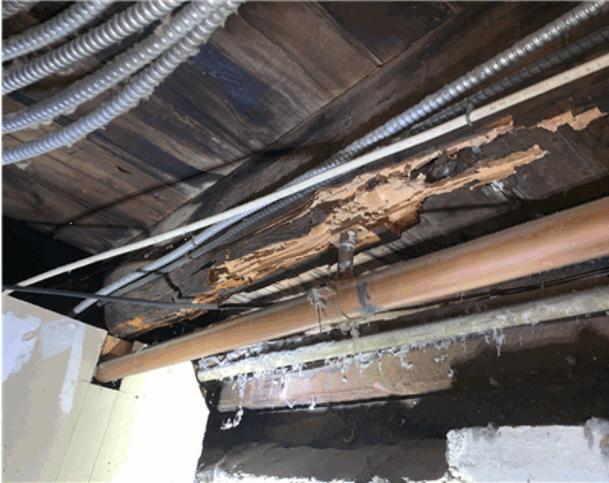
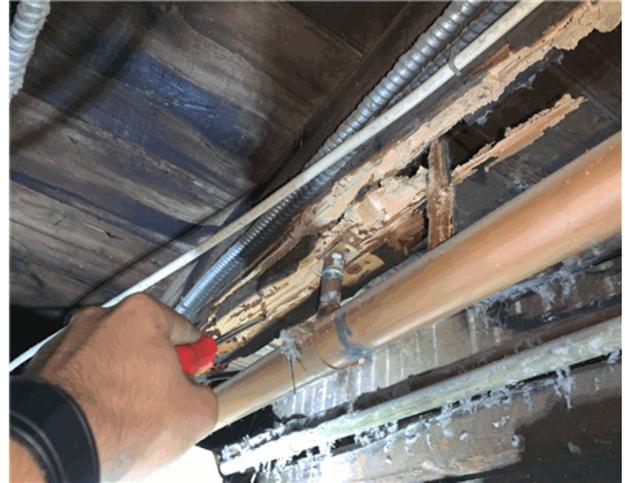
Heavy wood destroying insect related observed in basement.

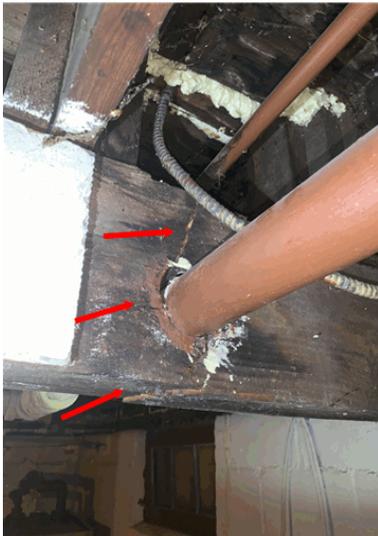
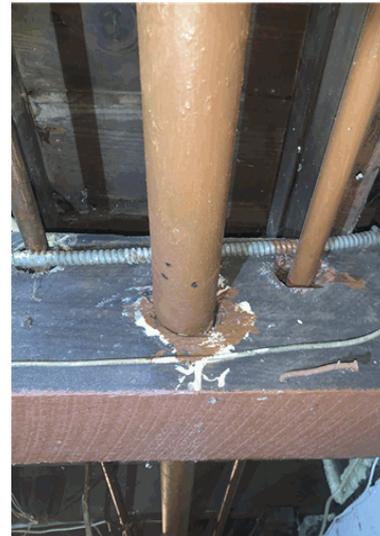
The beam had a 2in. hole bored through with a steam pipe in one area, which appears to have caused shear cracks. Additionally, the beam was observed to be bored in an alternate areas in the main beam. The main beam should never be cut or notched in any way shape or form. It is suggested that a "Licensed General Contractor" be contacted for further evaluation and repair.

Main beam had 2in hole bored through it with stress cracks.

Multiple bored holes observed in main beam.
